SEISMIC COSTS AND POLICY IMPLICATIONS

THE COST OF SEISMIC UPGRADING IN UNREINFORCED MASONRY RESIDENTIAL
BUILDINGS AND POLICY IMPLICATIONS FOR MAINTAINING AN AFFORDABLE
HOUSING STOCK.

City of Los Angeles
Community Development Department
Rent Stabilization Division

February 1989

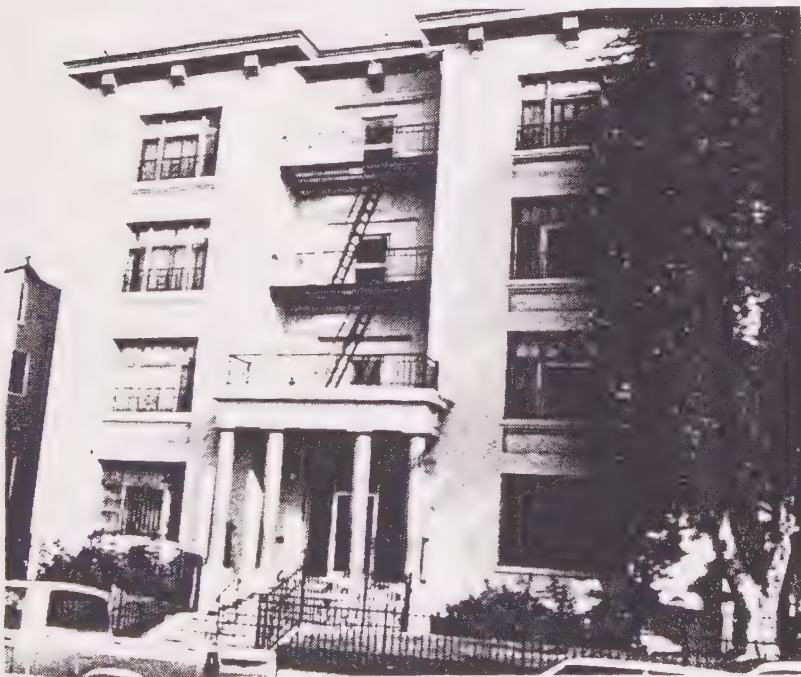
The building is on a sloping site and only the front half of the first floor is useable floor space. The building also has one interior transverse masonry wall which is unusual. There has been some damage in the back wall due to settlement, which increased retrofit cost.
